Technical Service Bulletin

Number: TSB-180 Date: May, 2010
Affected Part(s): Model E and L Repair Kits

Model E & L Secondary Levers

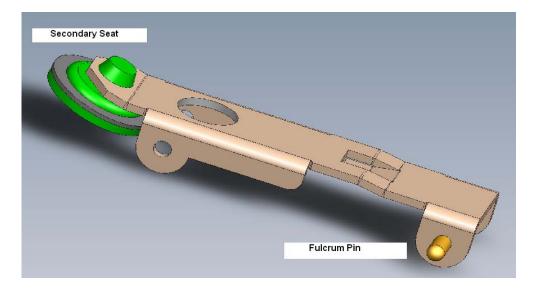
A change has been made to the model E and L repair kits. The secondary lever for the model E was preassembled with the fulcrum pin and secondary seat. The lever, pin and seat are now supplied as separate part items in the repair kit and must now be assembled by the rebuilder.

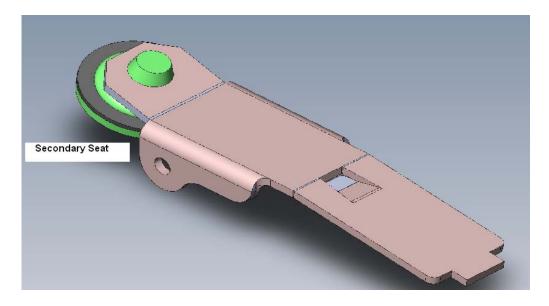
The secondary lever for the model L was supplied with the secondary seat pre installed. The lever and secondary seat are now supplied as separate part items and must now be installed by the rebuilder. The repair kit instructions have been updated to reflect this change.
